# Preliminary Structural Assessment Memorandum

August 21, 2026

| <b>Project name</b> | CCHD Structural Engineering Inspection | | |
| <b>Subject</b> | Preliminary Structural Conditions Assessment | | |

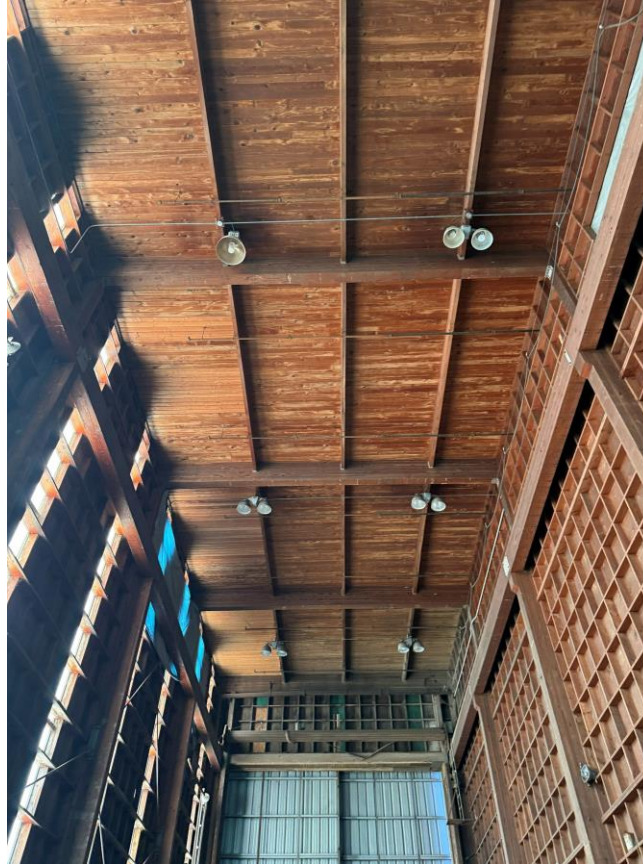
*Figure 3: Boat Yard – Roof System.*

The high bay roof framing and roof covering could not be safely accessed or fully visually evaluated as part of this assessment; therefore, the condition of the roof structure is unknown. Because the building is located in a coastal harbor environment and is exposed to wind-driven moisture and marine conditions, concealed deterioration may be present in roof framing, roof sheathing, connections, or related load-path elements that could not be directly observed during the site visit.

The roof structure should be evaluated during future investigation or repair planning. If deterioration, moisture-related damage, or lack of well defined diaphragm system or other load-path elements are identified, then potential improvements may include roof framing repairs, sheathing replacement, diaphragm strengthening, and improved roof-to-wall connections. Additional field verification should be performed to document the existing roof framing configuration, member sizes, connection conditions, and the extent of any concealed deterioration before repair or retrofit documents are developed.

Re-evaluation should be considered if water intrusion, roof distress, visible deflection, storm-related damage, or deterioration of adjacent wall framing is observed. Additional structural analysis and seismic evaluation may be required if future work includes significant roof framing repairs, diaphragm strengthening, or modifications to the lateral-force-resisting system.

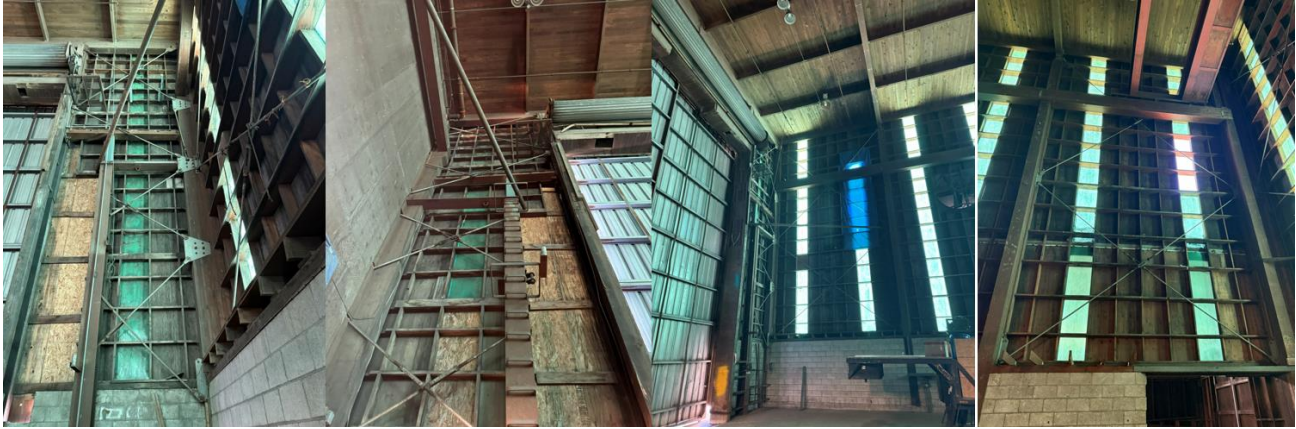
*Figure 4: Boat Yard – Modified cross bracing.*

The high bay portion of the Boat Yard Building includes large west-facing access openings that were reportedly provided to accommodate the movement of boats into and out of the building. The west face of the building includes exposed lateral bracing elements that appear to have been modified or altered at some point to accommodate changes to the large sliding doors, see Figure 4. Due to the size of these openings and the apparent modifications to the exterior bracing, additional evaluation may be warranted if repair, retrofit, or reuse of the building is pursued.

Re-evaluation should be considered if movement at the large access openings, connection deterioration, storm-related damage, or additional modifications to the lateral bracing system are observed. Permit-level documents may need to include structural repair details, calculations for affected members or connections, construction sequencing, material specifications, and special inspection requirements, where applicable.

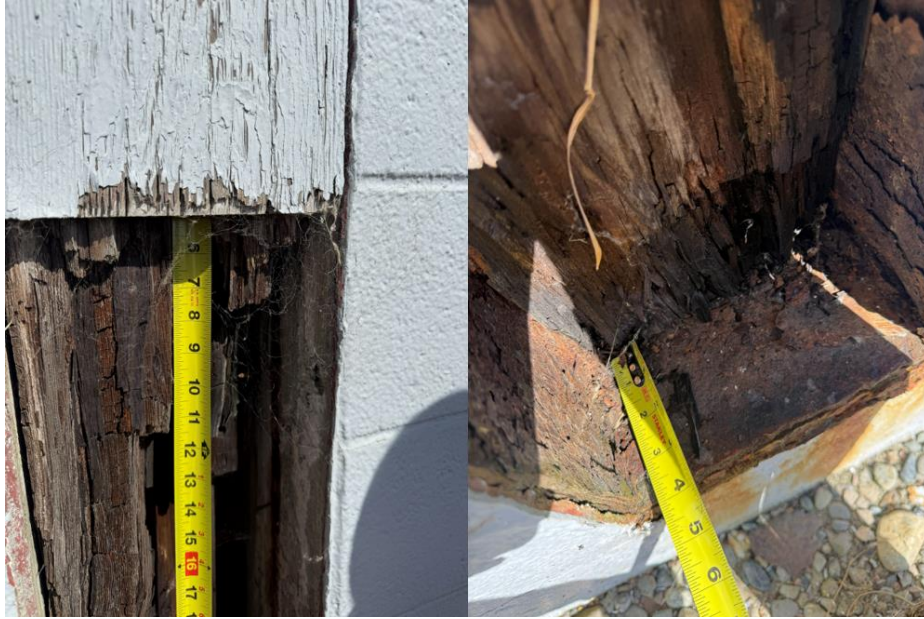
*Figure 5: Boat Yard – Damage to exterior wood post along south side of the structure.*

The west and south sides of the high bay structure appear to be more directly exposed to prevailing coastal weathering effects. These building sides were observed to be weathered, with visible deterioration of exterior wood elements. Several exterior columns exhibited deterioration, softening, decay, or localized material loss, particularly at exposed exterior faces, see Figure 5 and Figure 6.

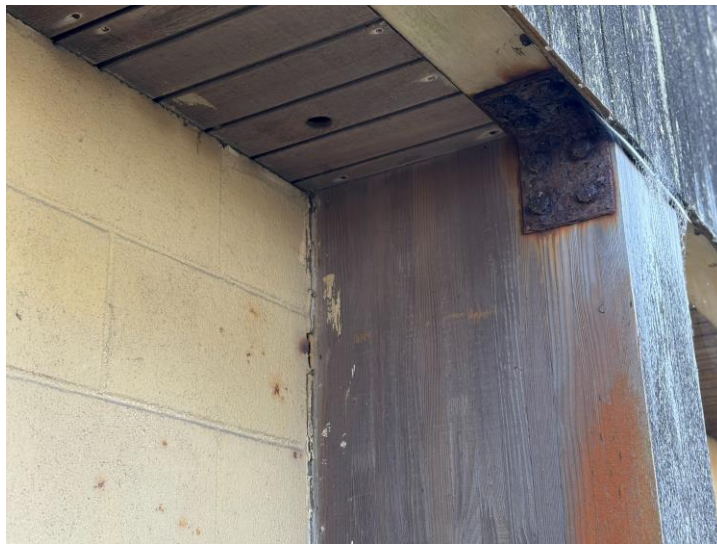
*Figure 6: Boat Yard – Corroded Hardware on north side of the structure.*

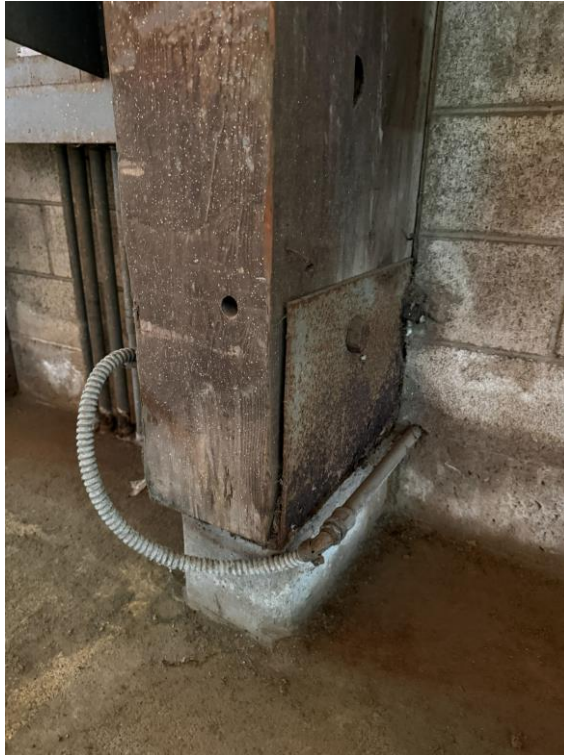
*Figure 7: Boat Yard – Interior column  
with no visible damage*

The interior faces of some of these members appeared to be in better visible condition than the exterior faces, see Figure 7; however, the full extent of deterioration could not be confirmed without additional intrusive investigation. Continued decay, softening, or section loss at exterior columns and wall framing has likely reduced member capacity over time and may affect the performance of the building envelope and structural load path.

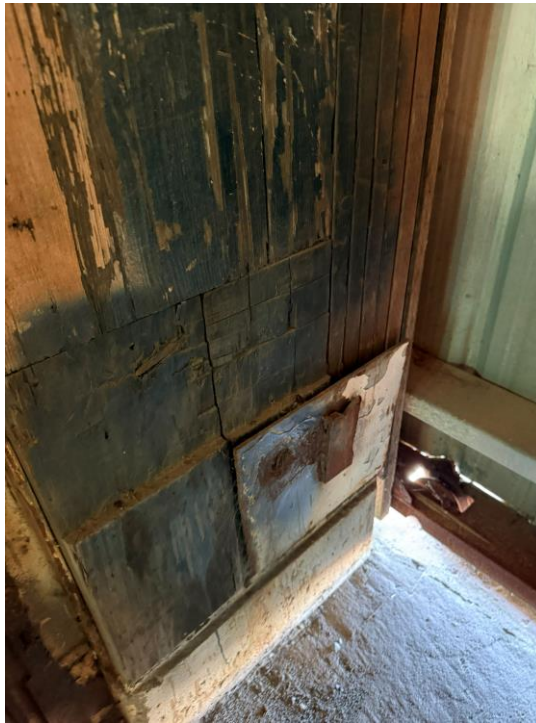
*Figure 8: Boat Yard – Interior modified post at southeast corner.*

A previous localized repair was observed at a column near the southeast corner of the high bay structure, adjacent to one of the west-facing bay door openings, see Figure 8. The repair appears to include replacement of portions of the built-up wood column laminations with new 2x material. The attachment method and load transfer mechanism could not be verified during the visual assessment. It is unknown whether the replacement material was mechanically fastened, glued, or installed without a defined structural connection, and it is unknown whether temporary shoring or jacking was used during the repair.

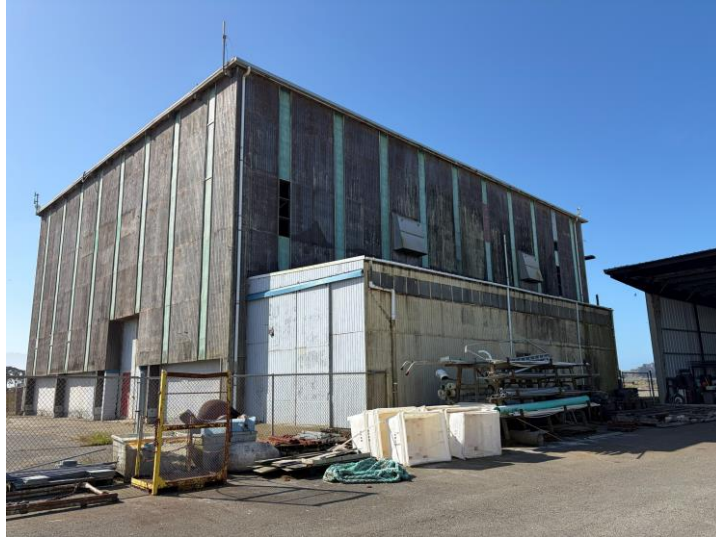
*Figure 9: Boat Yard – Exterior siding for high and low bay.*

The high bay structure generally consists of wood-framed exterior walls, wood roof framing, large west-facing access openings, and mezzanine interior office areas constructed within the high bay structure. The first 10 feet of the high bay structure consists of CMU wall construction. A smaller low bay structure is attached to the north side of the high bay structure and is shown with light-colored siding in Figure 9.

The west and south sides of the high bay structure were observed to be weathered, with visible deterioration of exterior wood elements. Other observed conditions included missing or damaged window panels on the north side of the building, as shown in Figure 9. Missing or damaged exterior envelope components may allow moisture intrusion into concealed framing or connection locations.

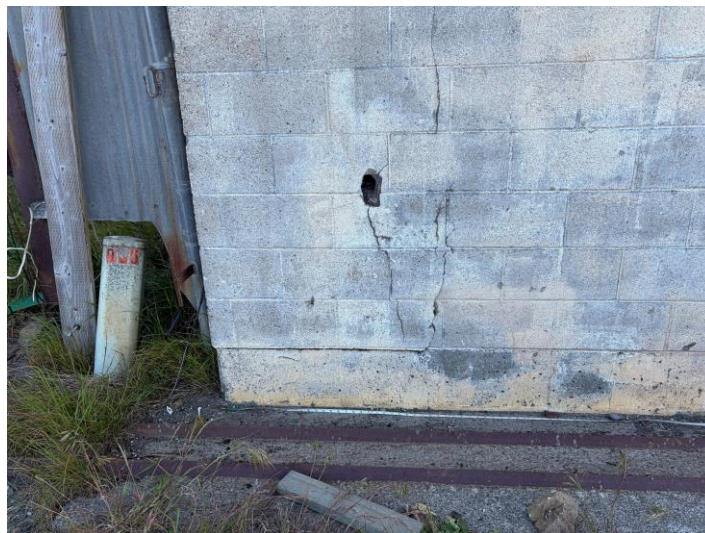
*Figure 10: Boat Yard – Cracked CMU wall.*

Cracking was observed at the CMU wall near the northwest corner of the high bay structure, as shown in Figure 10. This area should be monitored for worsening cracking, displacement, or water intrusion, and localized CMU repair or crack sealing should be considered to reduce water intrusion and resist further cracking.

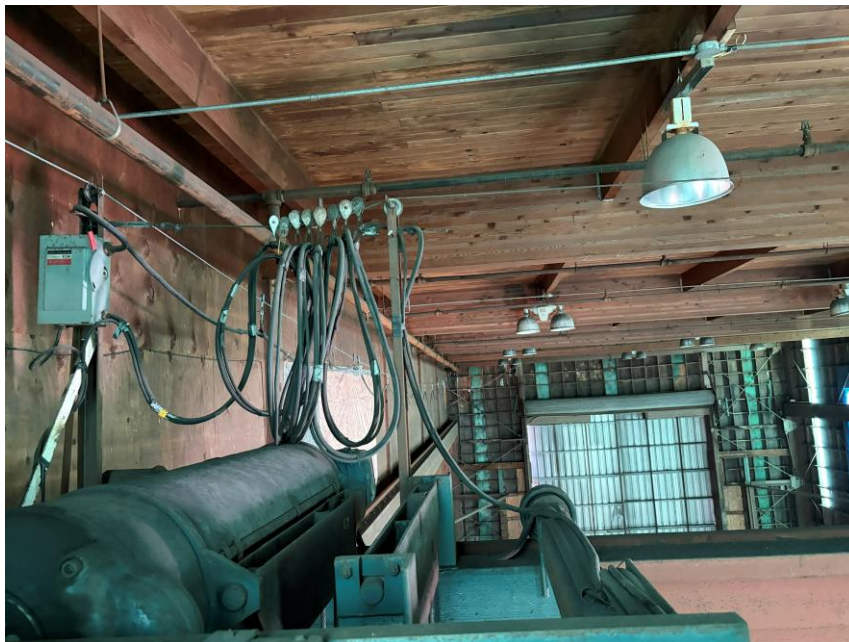
*Figure 11: Boat Yard – Crane beam.*

The building was reportedly originally used for construction and repair of large boats and includes a dry dock area and rail system that allowed boats to be moved between the harbor and the interior of the structure. Inside each of the two high bay structures, approximately 10 feet from the bottom of the roof system, is a beam crane system that runs the full length of the building, seen in Figure 11. However, the condition, configuration, and capacity of any crane beam support system were not fully evaluated as part of this screening-level visual assessment and inability to access the crane system.

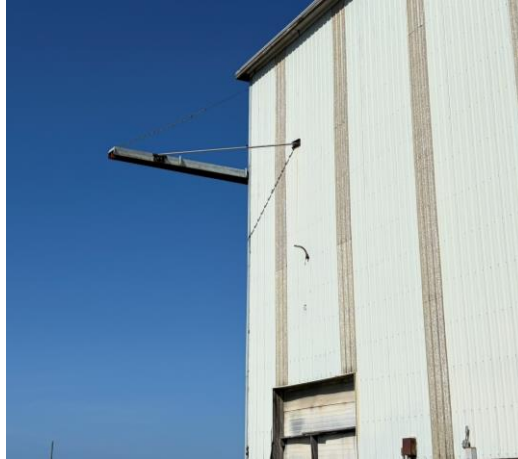
*Figure 12: Boat Yard – Access Door Frame*

Two large access door openings are located on the west side of the high bay structure to accommodate movement of boats into and out of the building. The doors have cantilevering support beam systems that hang off the exterior of the building, seen in Figure 12. These support systems may affect the local support and lateral load path around the openings.

Re-evaluation should be considered if movement, binding, connection deterioration, deformation, or damage is observed at the large sliding doors, door hanger components, or adjacent wall framing.

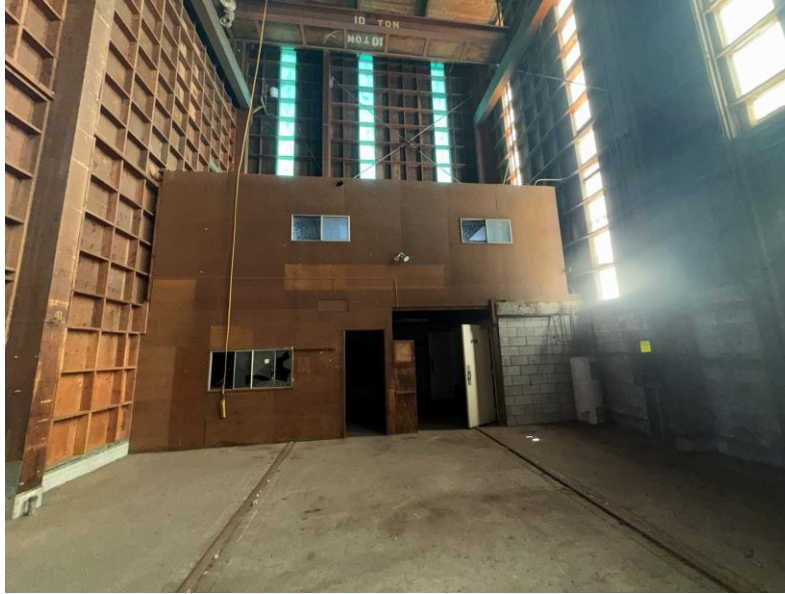
*Figure 13: Boat Yard – Interior mezzanine with storage and bathrooms on the lower floor and offices above.*

Interior mezzanine office areas were constructed within the high bay structure. Portions of the interior office areas are finished, shown in Figure 13, and some structural elements in these areas were concealed by wall, ceiling, or other finish materials. Where visible, portions of the interior framing did not exhibit the same level of weathering observed at the exterior building faces. However, because portions of the office areas were concealed by finishes, the condition of hidden framing, connections, and load-path elements could not be fully evaluated.

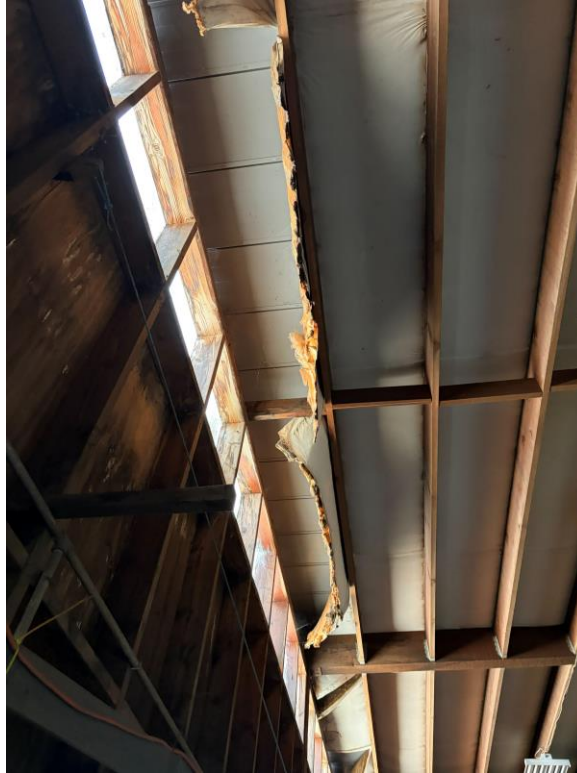
*Figure 14: Boat Yard – Low Bay roof system, standing seam metal roof over wood rafters.*

A smaller low bay structure is attached to the north side of the high bay structure and is visible as the light-colored siding shown in Figure 2. The low bay roof appears to consist of standing seam metal roofing supported by wood rafters, as shown in Figure 14. Based on visual observations, plywood sheathing, steel roof decking, or another continuous roof diaphragm system was not observed; however, the roof assembly should be further verified during future investigation.

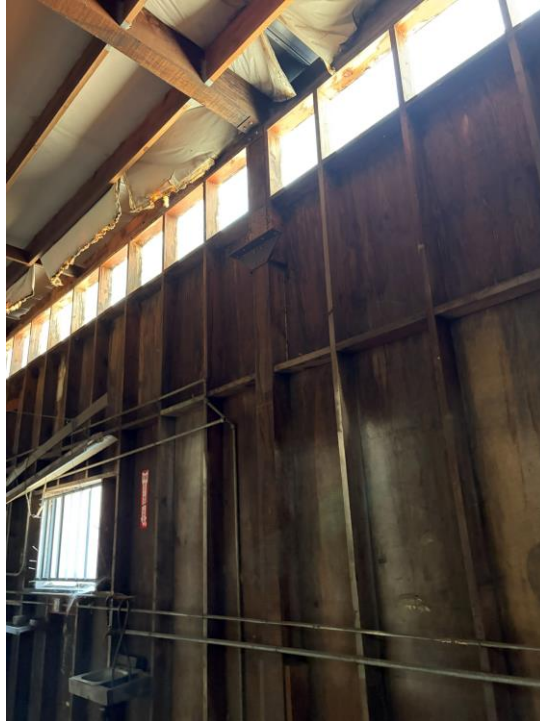
*Figure 15: Boat Yard – Low Bay lateral wall system.*

The low bay structure is attached to the north side of the high bay structure. The visible wall framing appears to consist of balloon-framed wood wall construction, as shown in Figure 15. Based on the visual observations, the configuration, continuity, and adequacy of the low bay lateral-force-resisting system could not be confirmed. No visible anchor bolts were observed at the wall base in the area shown; however, the presence or absence of concealed anchorage could not be verified without additional investigation.

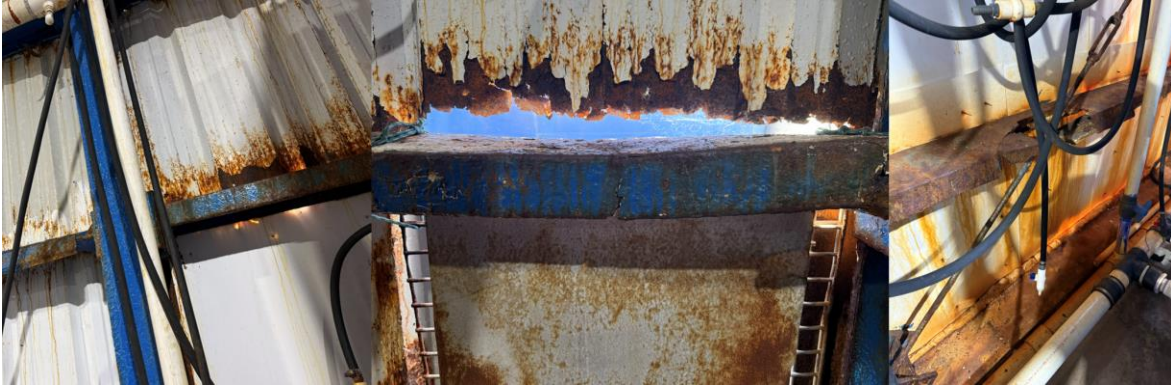
*Figure 17: Fish Processing Facility 1 – Extreme deterioration in wall girts along south-west corner.*

The most significant observed deterioration was located along the southwest corner of the structure. Exterior metal siding, wall girts, and other secondary framing elements exhibited visible corrosion and rust staining, see Figure 17. Some wall girt sections appeared to be heavily deteriorated, with localized areas of section loss or missing material. Openings and rusted holes in the exterior siding (Figure 18) have exposed wall framing, wall girts, and bracing elements to continued moisture and coastal exposure.

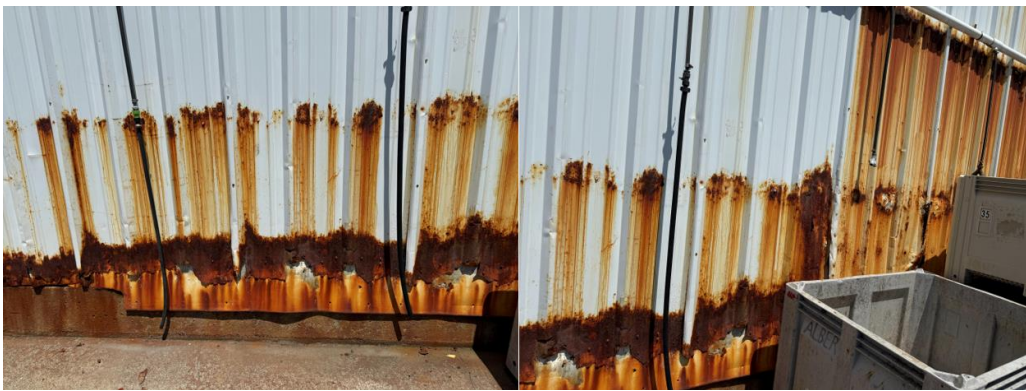
*Figure 18: Fish Processing Facility 1 – Deteriorating exterior siding causing framing members to fail.*

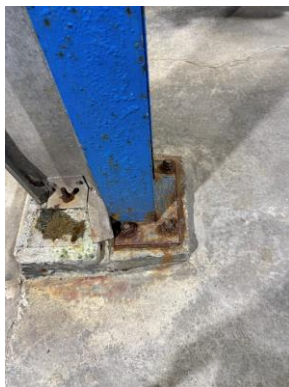
*Figure 19: Fish Processing Facility 1 – Interior column base with corroding base plate, and bubbling paint.*

Exterior columns, base plates, and anchor bolt locations along the southwest side of the structure exhibited visible corrosion and rust staining, see Figure 19 and Figure 20. The condition of concealed or embedded portions of the anchorage could not be fully evaluated through visual observation. Continued corrosion at these locations may reduce connection capacity over time and may affect the transfer of gravity, wind, or seismic loads between the steel superstructure and the foundation.

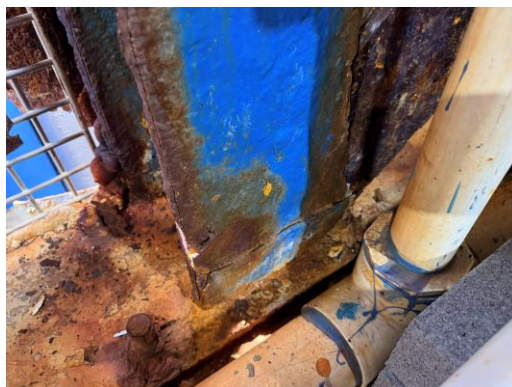
*Figure 20: Fish Processing Facility 1 – Exterior column deteriorating, and paint flaking from structural members. Missing anchor bolt nuts.*

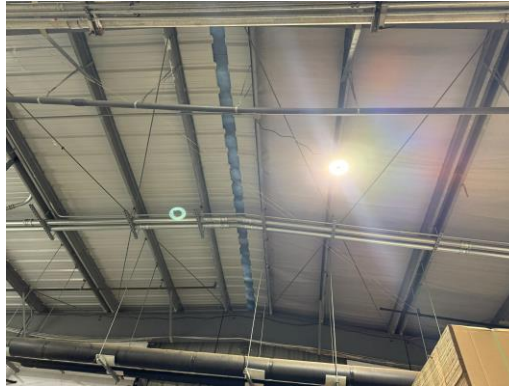
*Figure 21: Fish Processing Facility 1 – Roof lateral cross bracing in original structure.*

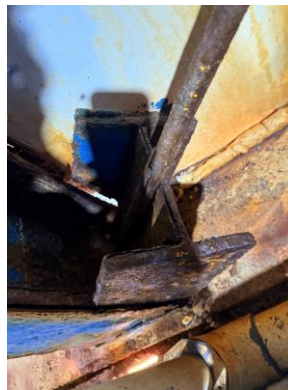
*Figure 22: Fish Processing Facility 1 – Corroding Lateral Bracing.*

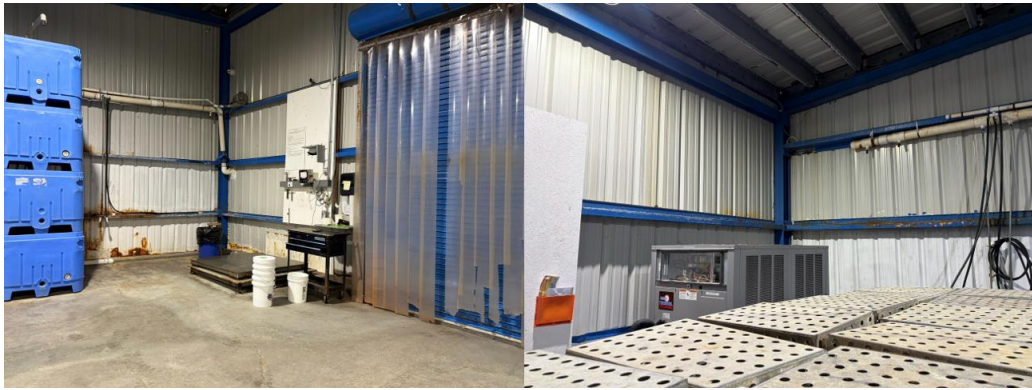
*Figure 23: Fish Processing Facility 1 – Missing or not visible bracing from secondary edition.*

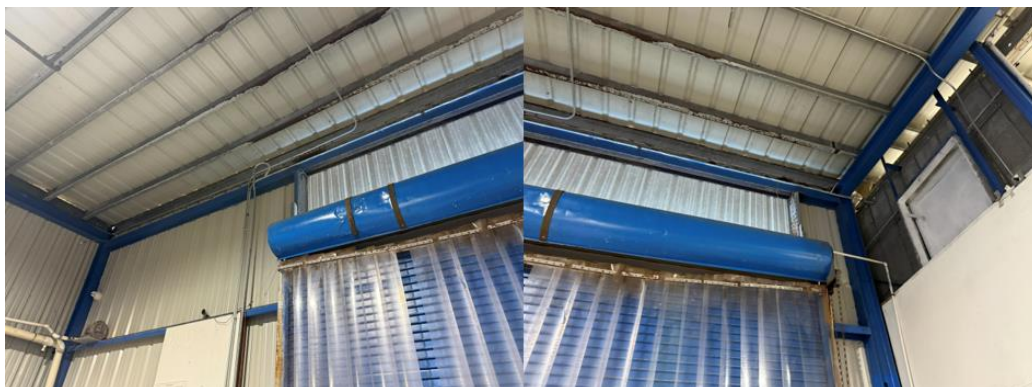
*Figure 24: Fish Processing Facility 1 – North wall with roll up door.*

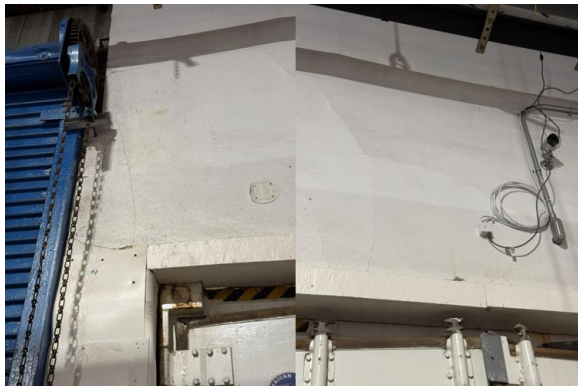
*Figure 25: Fish Processing Facility 1 – Cracking finished material above shipping containers cut into the north exterior wall.*

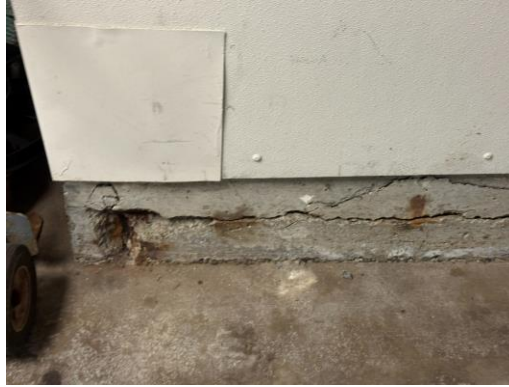
*Figure 26: Fish Processing Facility 1 – Cracking concrete curb, with rust stains coming from the cracks.*

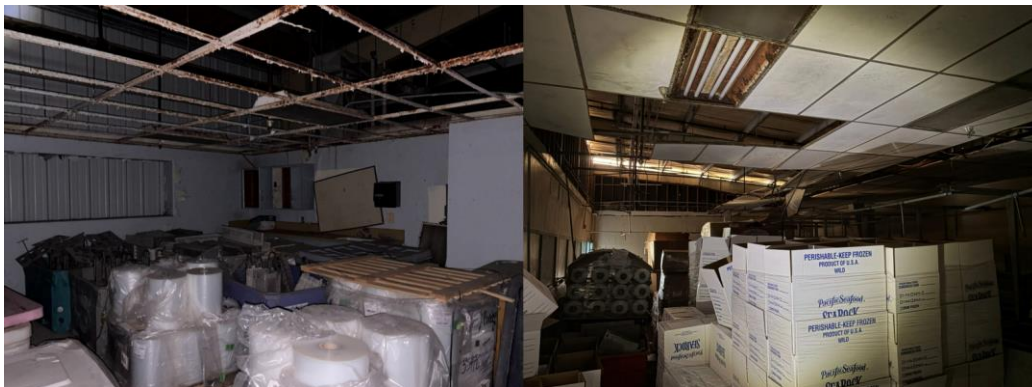
*Figure 28: Fish Processing Facility 2 – Degrading drop down ceiling.*

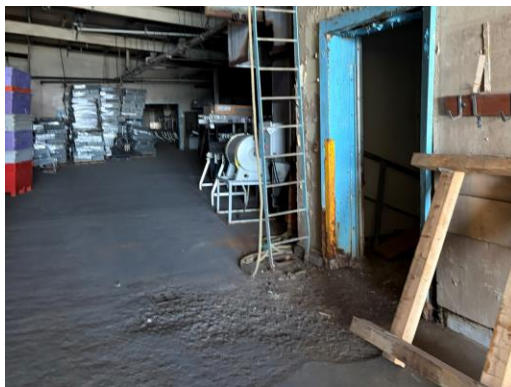
*Figure 29: Fish Processing Facility – Degraded concrete slab and curb.*

Localized deterioration was observed along the concrete curb or foundation area where equipment, reportedly an ice machine, previously discharged material toward a floor drain, seen in Figure 29. The affected concrete surface exhibited deterioration and apparent etching along the drainage path. Additional investigation would be required to determine whether the deterioration is limited to surface damage or whether embedded reinforcement, anchorages, or supporting concrete have been affected.

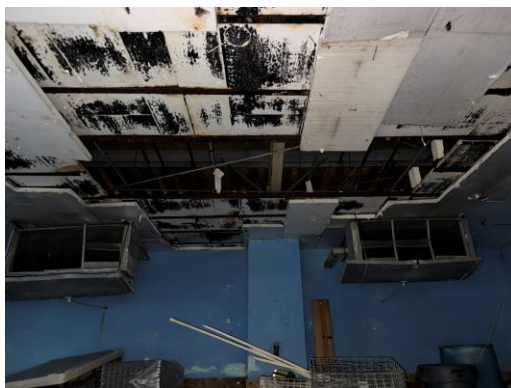
*Figure 30: Fish Processing Facility 2 – Degrading mechanical refrigeration units, and refrigeration insulation.*

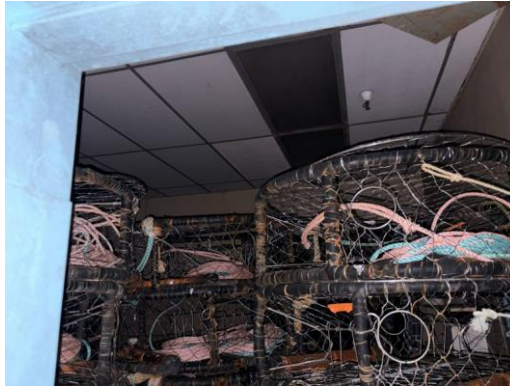
*Figure 31: Fish Processing 2 – Interior space with crab pots.*

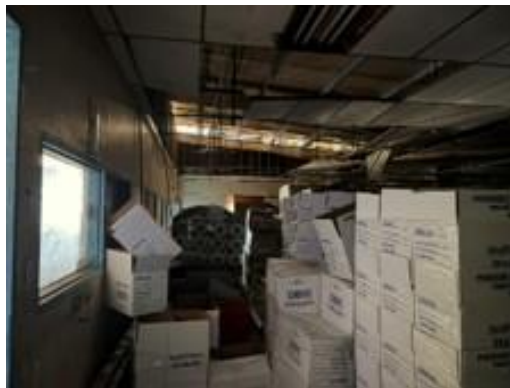
*Figure 32: Fish Processing 2 – Interior space with miscellaneous materials.*

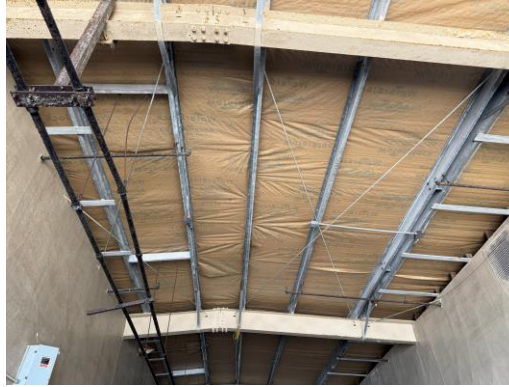
*Figure 33: Fish Processing 2 – Roof cross bracing.*

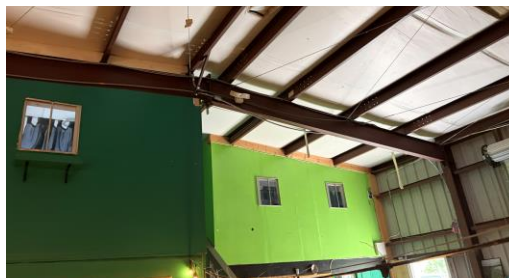
The Abalone Building was reportedly constructed for storage use and has since been modified to include living quarters. Based on the apparent original storage-type use of the building, the structure may not have been designed for residential or living-space occupancy loads, serviceability requirements, or related code requirements. Evaluation of zoning, permitting, fire/life-safety, accessibility, energy code, and occupancy compliance associated with the living spaces is excluded from this structural assessment.

*Figure 36: Abalone Building – Added living spaces along east side of the structure*

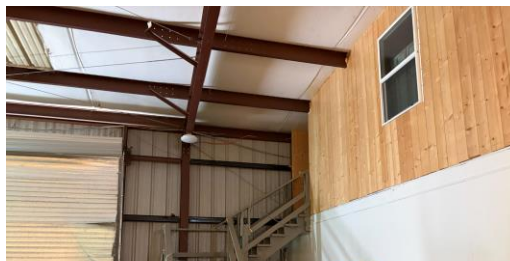
**Figure 37: Abalone Building – Added living spaces along the west side of the structure.**

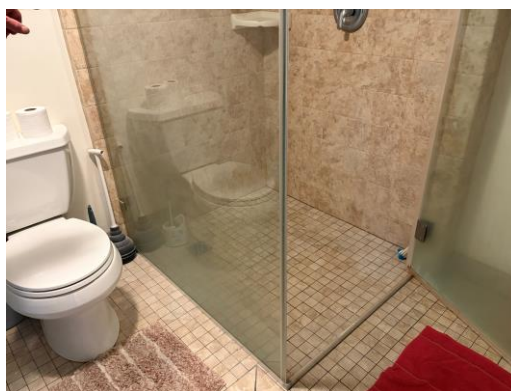
**Figure 38: Abalone Building – Added bathroom in northwest corner.**

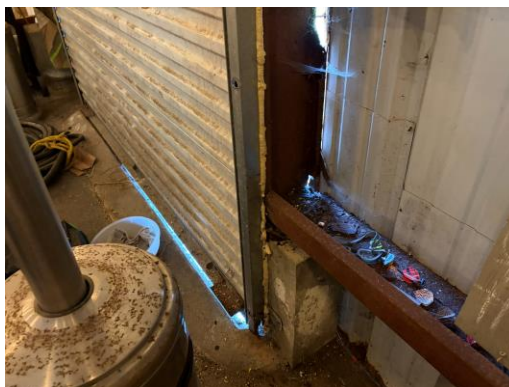
*Figure 39: Abalone Building – Rusting roll up door frame along north side of the structure.*

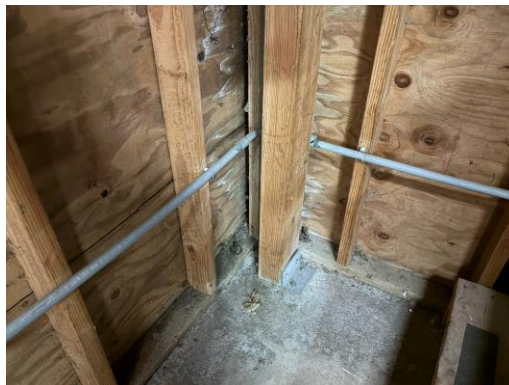
*Figure 41: Coast Guard Building – Post foundation connection.*

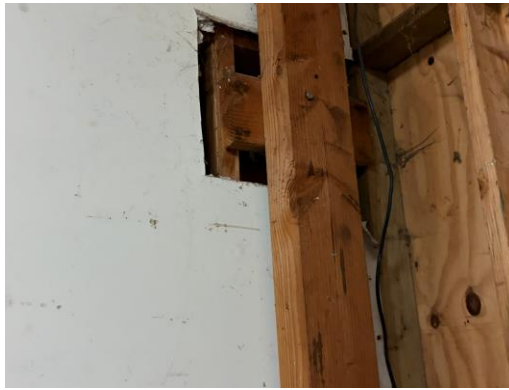
**Figure 42: Coast Guard Building – Corner post frame to double wide mobile structure.**

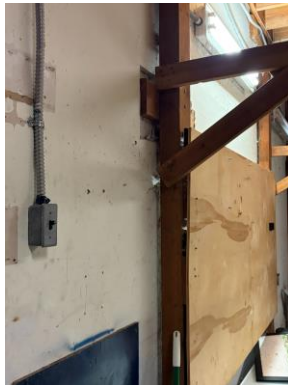
**Figure 43: Coast Guard Building – Middle post frame to double wide mobile structure.**

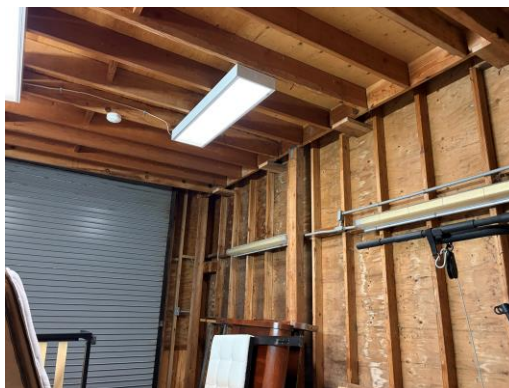
**Figure 44: Coast Guard Building – Upper platform inside west side addition.**

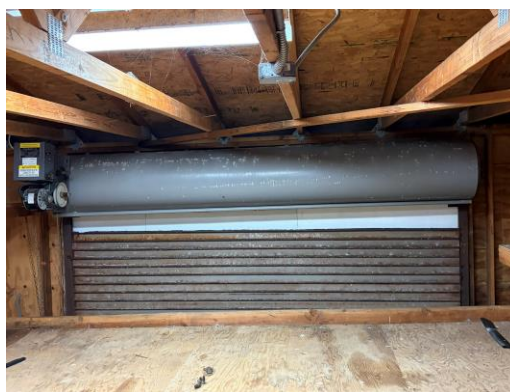
*Figure 45: Coast Guard Building – Roll up door with door torn off from the top motor.*

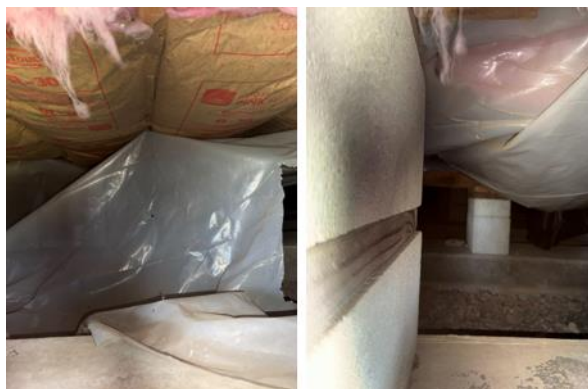
*Figure 46: Coast Guard Building - Portable structural crawl space.*

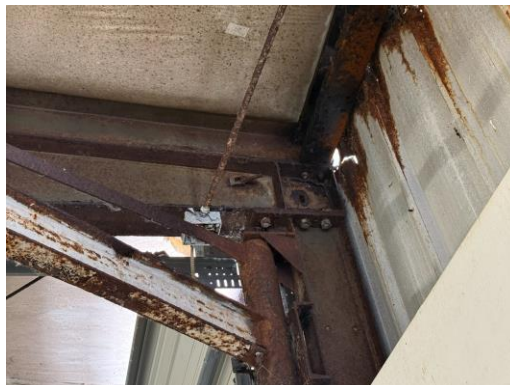
*Figure 48: Storage Building – Rusting roof eave members.*

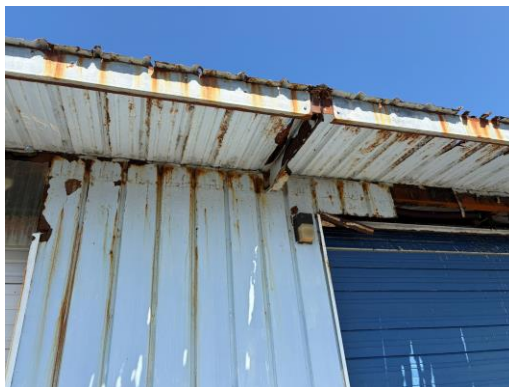
*Figure 49: Storage Building – Rusty exterior siding.*

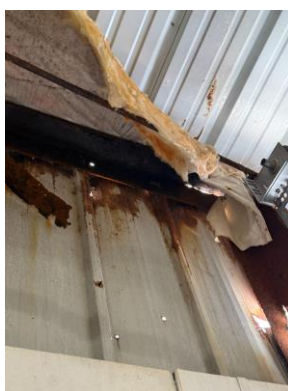
*Figure 50: Storage Building – Failing exterior siding.*

The deteriorated siding and wall framing may allow continued moisture intrusion and exposure of steel framing to coastal air, which could accelerate corrosion and section loss. Where wall framing or siding deterioration occurs near bracing, connections, or openings, the condition may also affect the continuity of the wall system and the building's ability to resist wind or seismic loads.

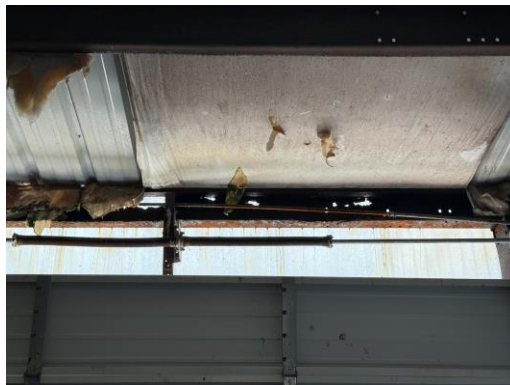
*Figure 51: Storage Building – Degraded exterior doorway framing.*

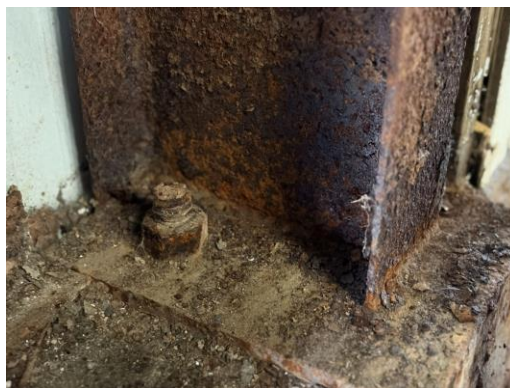
*Figure 52: Storage Building – Failing column post.*

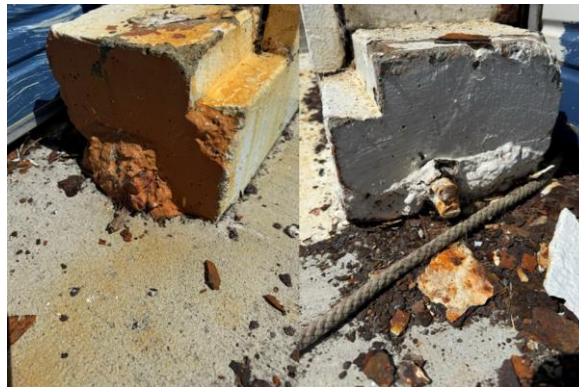
*Figure 53: Storage Building – Cut concrete curb, and corroding reinforcement.*
