# Technical Memorandum

September 17, 2026

| <b>Project Name</b> | Crescent City Harbor District Marina H Dock Repair Concepts | | |
| <b>Subject</b> | Marina H Dock Repair Concept Summary | | |

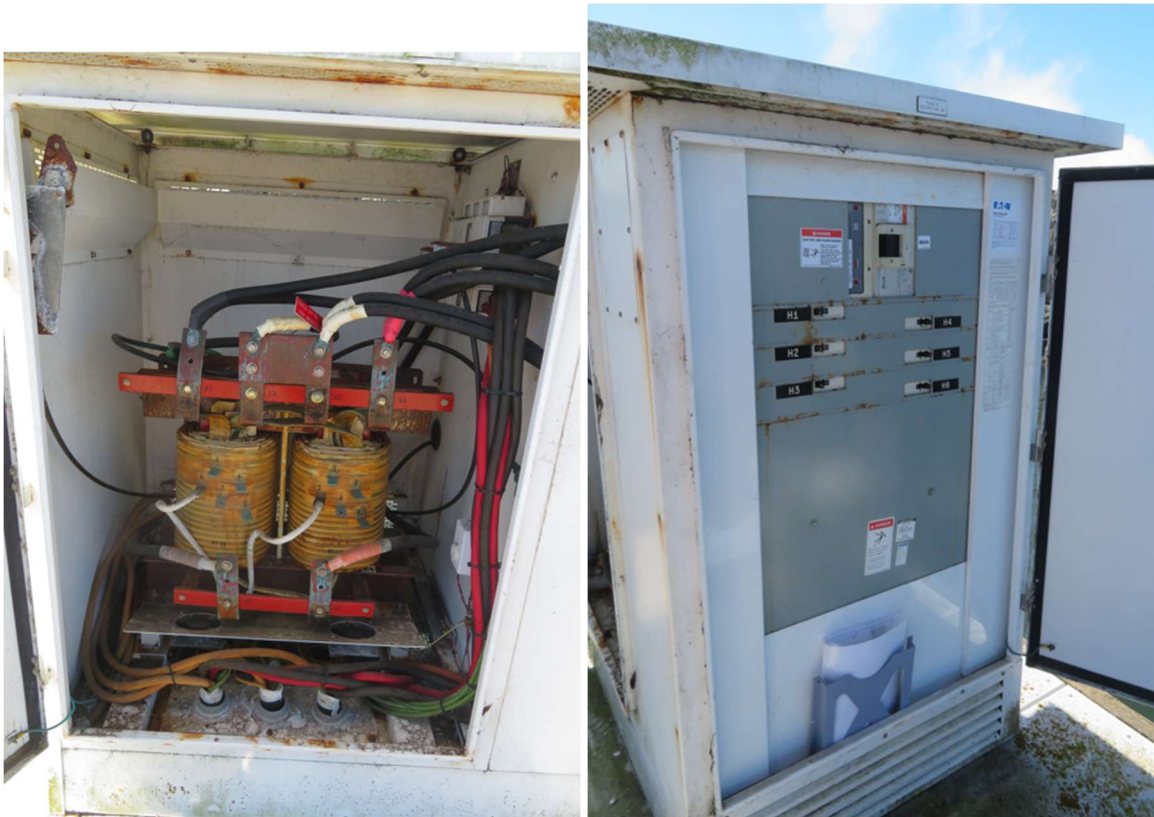
- The existing transformer and load panel at float MM08 (see Figure 4) and CCHD noted that it was previously tested by an electrician and found to be in acceptable condition. The transformer is currently shut off due to damage to the electrical wiring on Dock H.
- Wiring between floats was severed in many locations, as shown in Figure 6. Wiring within the conduits within the float is expected to be undamaged and remain in place, but will need to be replaced due to the severed connections between floats. Based on the observed conditions in the pull box on HM01, as shown in Figure 5, the wiring appears consistent with that shown in the construction drawings.
- While on site, CCHD personnel noted that there is ongoing regular abrasion of the electrical lines between floats due to rubbing with the concrete as well as with barnacles and other biological growth, as shown in Figure 6.

**Figure 4: Combined Transformer and Load Panel at float MM08**

- 1) The existing transformer at float MM08 is provided with new penetrations on the side of the box that allow for access to the transformer.
- 2) New temporary lines are installed from the transformer to the pedestals, run in conduits on the surface of the deck with flexible connections at each float to float connection
- 3) Potable water is rerouted to new hose lines also run above the deck to the pedestals as necessary
- 4) A plywood walking surface is then built around the temporary line runs to protect the runs from vessel operations. This walking surface will be wide enough and have sufficient vertical capacity to support vessel operations.

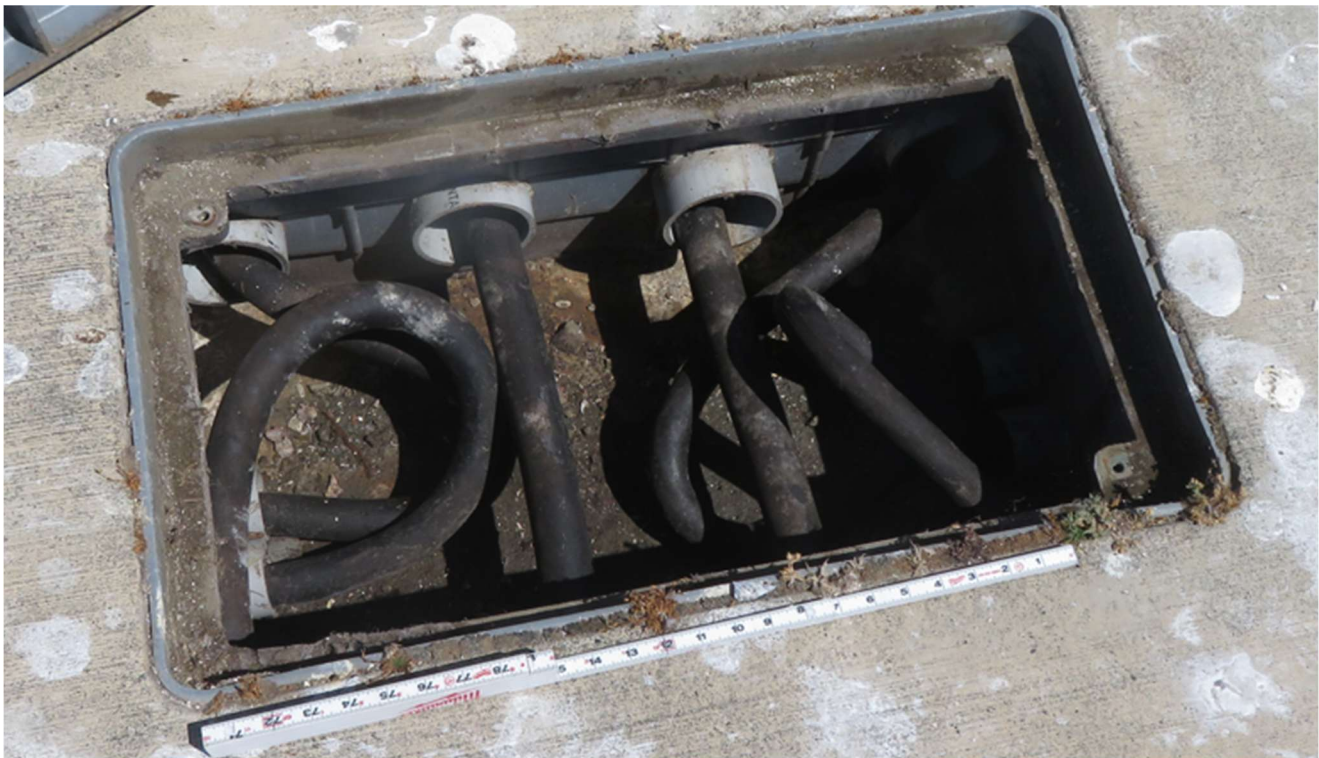
**Figure 5: Wiring at Pull Box on HM01**

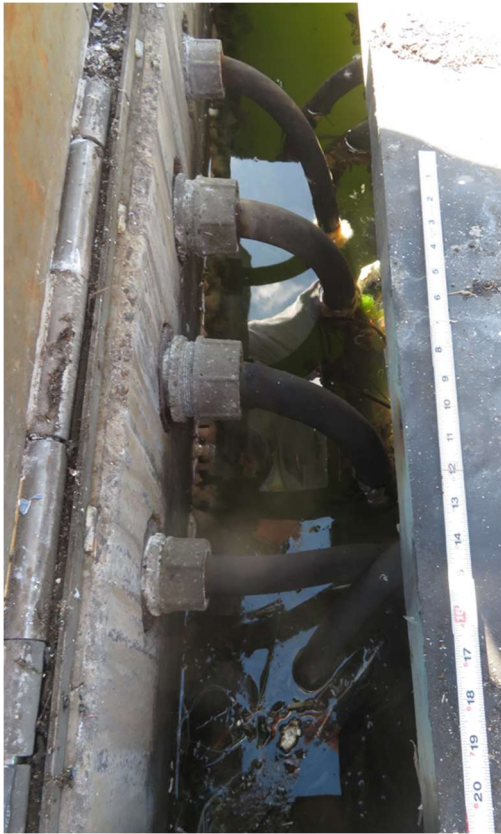
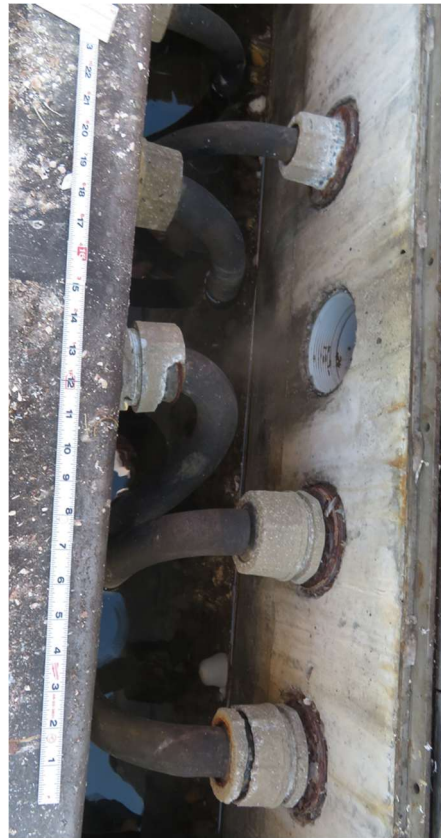
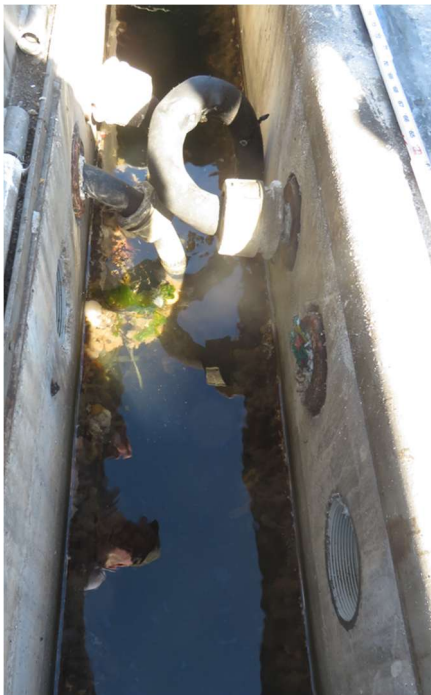
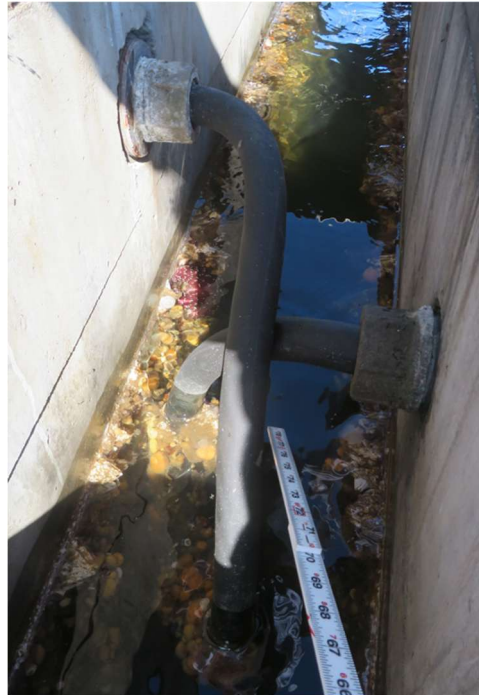
**Figure 6: Wiring Between Floats**

a) Wiring at HM01 to 02

b) Wiring at HM03 to 04

c) Wiring at HM05 to 06

d) Wiring at HM09 to 10

- 1) All electrical lines are removed from their existing conduits and replaced along the full length from the transformer to the pedestal as currently installed. This installation may require removal or intentional sinking of each float in order to clear the existing wire and install new wire along the runs. The final condition would be the same as the pre-2025 damage condition, with the exception that braided stainless steel wire sheathing would be installed over the new run of line at the float isolation to reduce abrasion on the lines from biologicals and concrete corners.

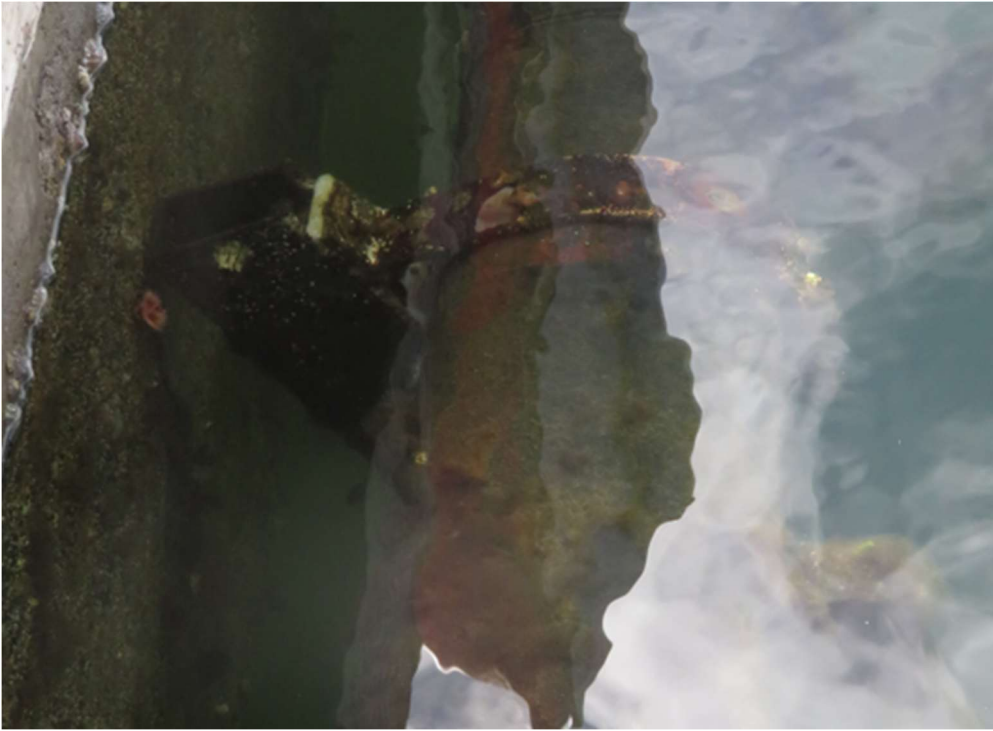
- Loss of the firewater and potable water support brackets due to failure of the bracket anchorage was noted at several locations throughout the marina as a systematic failure, similar to those shown in Figure 7 and Figure 8. As turbidity was high, GHD was not able to visually observe all locations of the bracketed connections at H Dock. CCHD will request all available inspection notes from M&N for review in order to better map damage locations for repair.

**Figure 7: Example Loss of Firewater Pipe Support (Not at Dock H)**

While the above scheme addresses many of the flexibility issues and maintenance challenges for the existing system, it does not address the ongoing damage experienced using Unistrut. The systematic failure of the brackets does not have a clear root cause and may be due to corrosion, overloading from the HDPE piping due to lack of flexibility, out of spec materials (such as use of 304 stainless versus 316 stainless), or some combination thereof. The localized repair scheme runs the risk of continued challenges following implementation of these repairs, therefore a more resilient repair scheme was also developed.

- 2) The existing stainless steel brackets would be supplemented with new Unistrut and brackets of 316 stainless steel material. The new Unistrut brackets would be installed above the waterline adjacent to the timber waler.

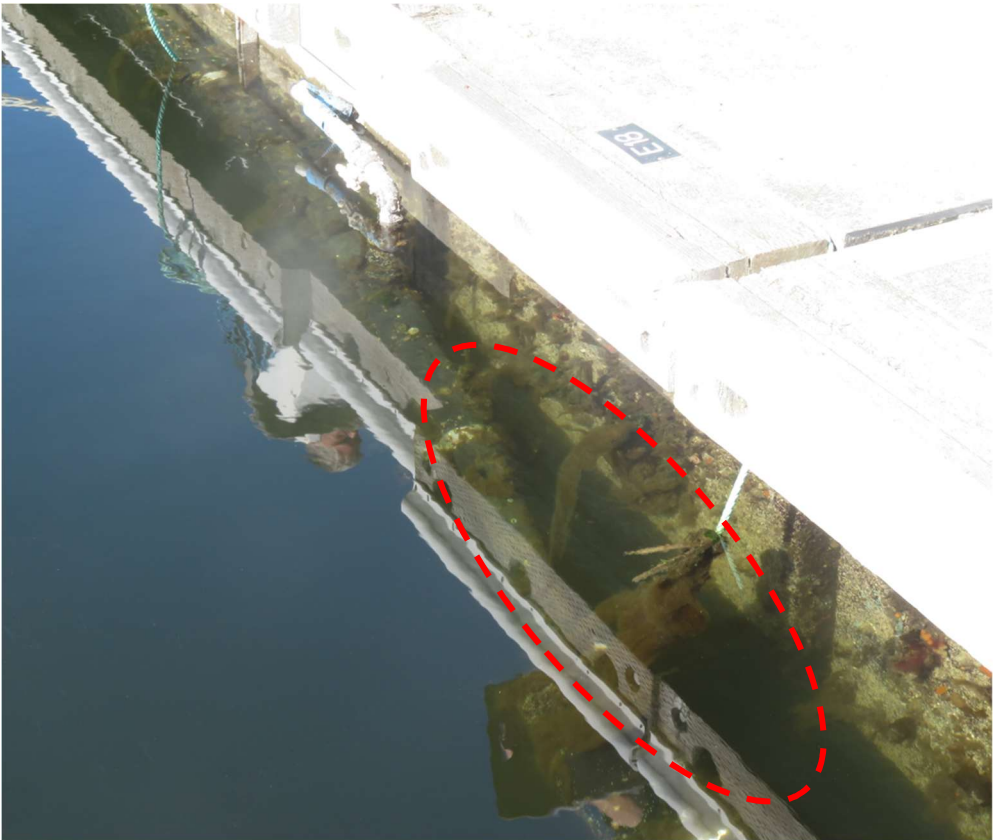
**Figure 8: Example Loss of Firewater Pipe Support (Not at Dock H)**

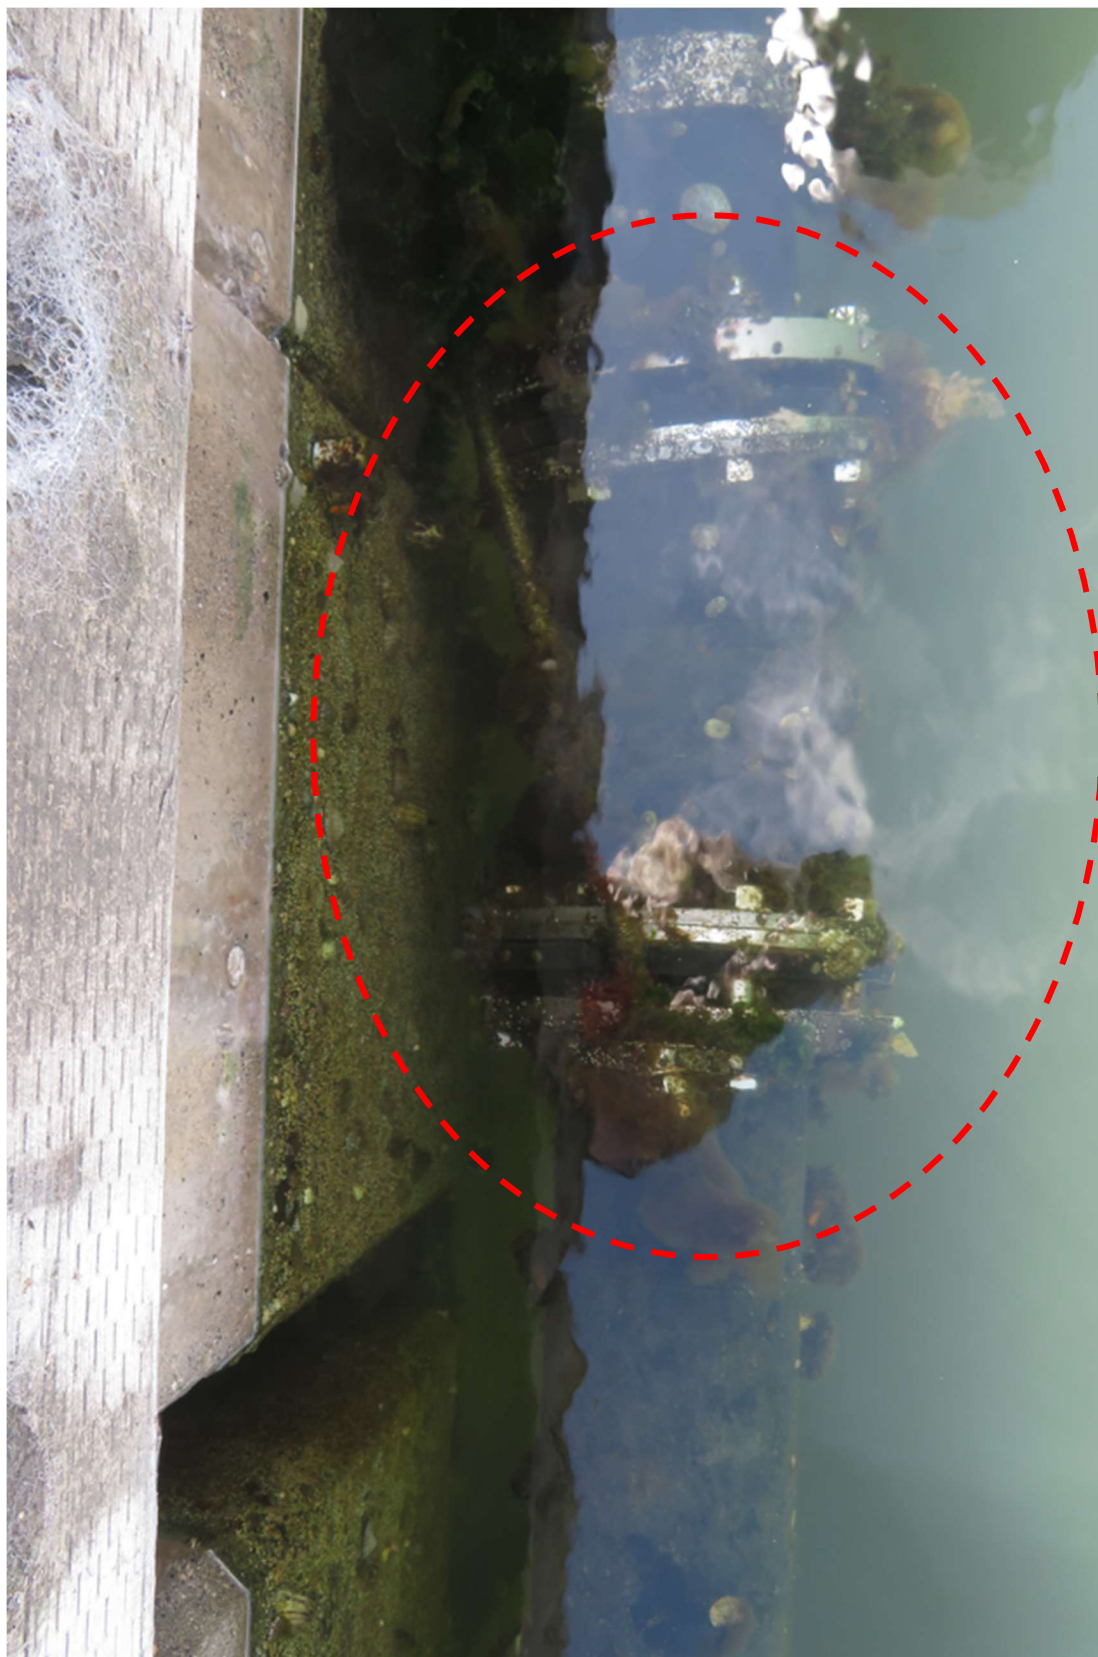
- GHD observed that the flexible connectors for the firewater line and potable water line used in final construction consist of a plastic or rubber bellow material which appear to be under constant compression in locations (not at H dock), as shown in Figure 9. It is believed that the bellows connector does not provide sufficient flexibility for the connected HDPE piping and that compressive forces are resulting in the piping, causing it to buckle and break the anchorage locations. GHD recommends that when a wider repair program is implemented, these bellows are replaced with a more flexible connection which does not result in axial loading of the HDPE piping.

**Figure 9: Typical Flexible Bellow Connection**

- 4) New posts are installed at the intersection of the floats for hanging a new flexible stainless steel braided line. The line will provide sufficient flexibility for all normal service movements and will be readily replaceable in the event of future tsunami induced excessive movements. A flanged connection will be added to the end of the HDPE lines to allow for future repairs.
