# Preliminary Structural Assessment Memorandum

August 21, 2026

| <b>Project name</b> | CCHD Structural Engineering Inspection | | |
| <b>Subject</b> | Preliminary Structural Conditions Assessment | | |

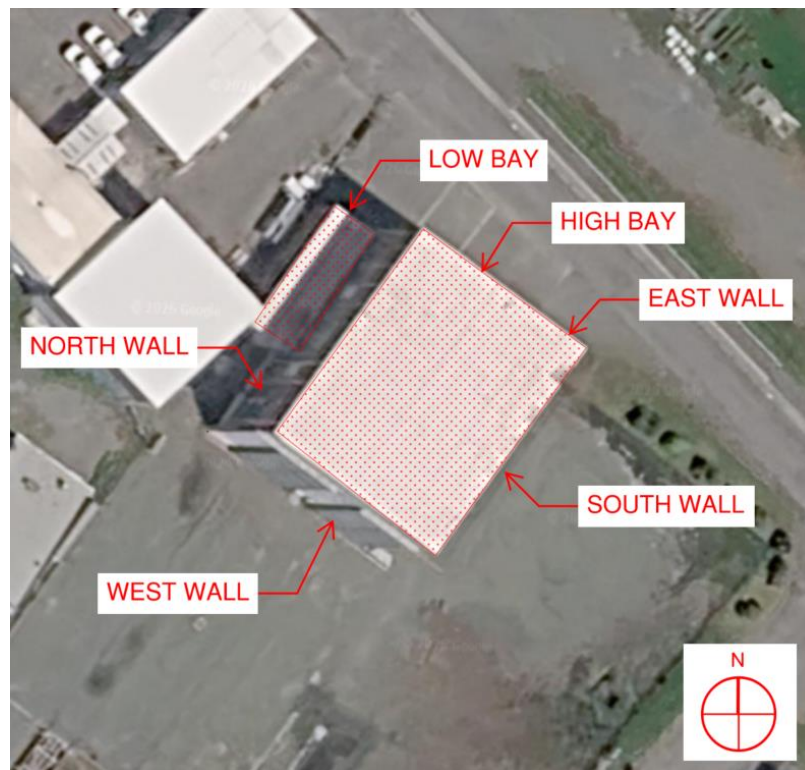
*Figure 2: Boat Yard – General plan and site orientation.*

The Boat Yard Building is a single-story wood-framed structure located at 121 Starfish Way near the harbor waterfront. The building generally consists of a taller high bay portion and a smaller low bay portion attached along the north side, see Figure 2. The high bay portion was reportedly originally used for construction and repair of large boats and includes large west-facing access openings, a dry dock area, and rail system for moving boats between the harbor and the interior of the building. Assessment of the dry dock area and rail systems are not included in the scope of this memorandum.

A smaller low bay structure is attached to the north side of the high bay structure and is visible as the light-colored siding shown in Figure 2. The low bay roof appears to consist of standing seam metal roofing supported by wood rafters, as shown in Figure 14. Based on visual observations, plywood sheathing, steel roof decking, or another continuous roof diaphragm system was not observed; however, the roof assembly should be further verified during future investigation.

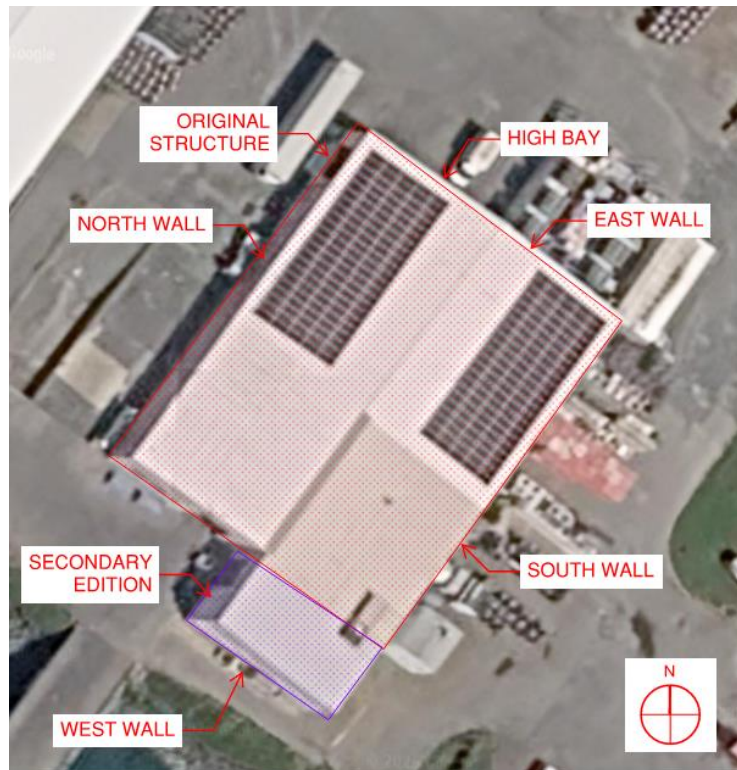
*Figure 16: Fish Processing Facility 1 – General plan and site orientation*

Fish Processing Facility 1 is a single-story pre-engineered metal building (PEMB) located at 161 Starfish Way see, see Figure 16. The building is currently used by a tenant for fish processing and flash-freezing operations. The building includes an original larger rectangular building section with a smaller steel-framed addition located along the west side.

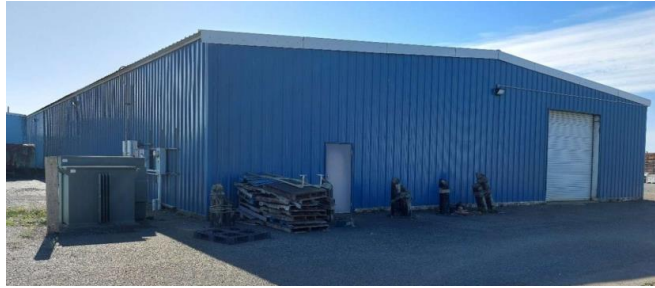
*Figure 27: Fish Processing Facility 2 – Exterior of building.*

Fish Processing Facility 2 is a single-story pre-engineered metal building (PEMB) located at 161 Starfish Way, adjacent to Fish Processing Facility 1, see Figure 27. The building is currently used by a commercial crabbing tenant for crab trap storage and processing-related operations. Water and power were not supplied to the building at the time of the assessment.

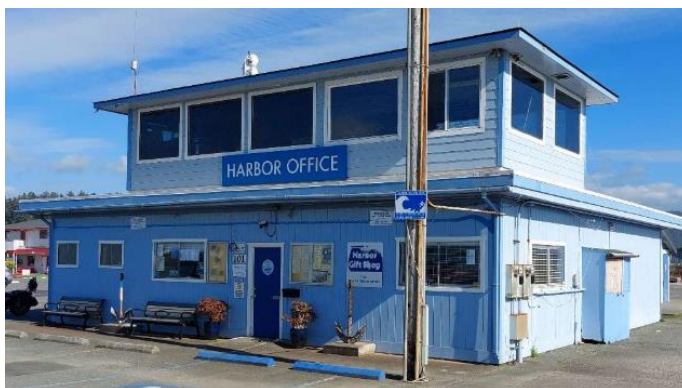
*Figure 34: Harbor District Office - Exterior view facing east.*

The Harbor District Office is a two-story wood-framed structure located at 101 Citizens Dock Road near the harbor waterfront, see Figure 34. The building is currently used as the Harbor District office and includes office areas, meeting spaces, and bathroom facilities. The building has reportedly experienced prior tsunami-related flooding associated with the 1964 tsunami event.

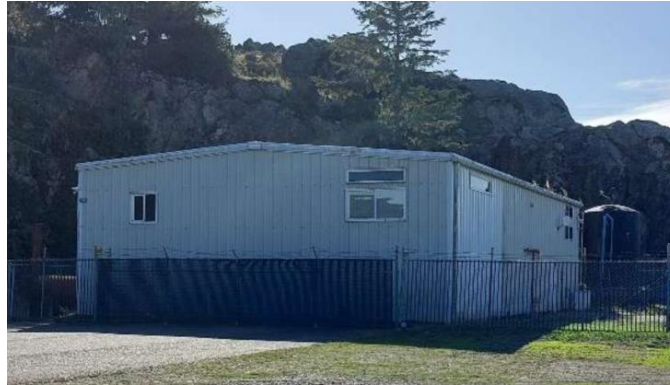
*Figure 35: Abalone Building - Exterior view.*

The Abalone Building is a single-story pre-engineered metal building located at 250 Anchor Way near the southeast portion of the property, see Figure 35. The building is partially bordered by a hillside, which appears to provide some protection from direct coastal wind exposure. The structure appears to have originally been constructed as a metal storage-type building and has since been modified to include living quarters, including bedrooms, a kitchen, and bathroom facilities.

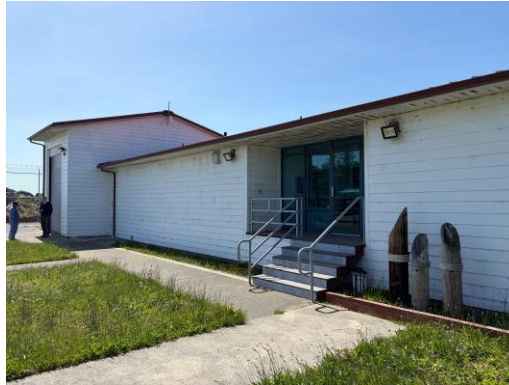
*Figure 40: Coast Guard Building*

The Coast Guard Building is located at 100 Anchor Way near the southeast end of the harbor. The building was reportedly previously used by the United States Coast Guard and generally consists of a double-wide portable wood-framed structure supported on concrete piers with an accessible crawl space, seen in Figure 40. The site is exposed to coastal wind and rain conditions, with a rock barrier located east of the building providing some protection from direct coastal exposure.

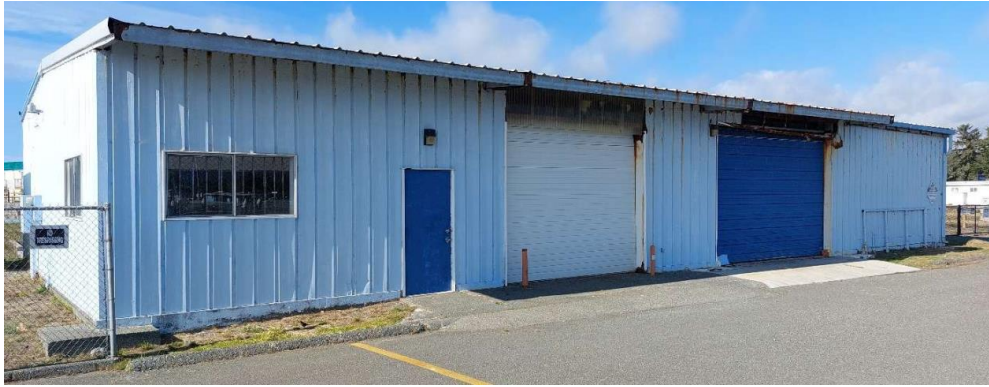
*Figure 47: Storage Building*

The Storage Building is a single-story metal building located off Starfish Way near the north side of the harbor, see Figure 47. The building was reportedly last used by the Sheriff's Office for storage and has since been unoccupied. The building generally consists of a steel superstructure with steel roof and wall purlins, metal roof decking, and metal wall siding.
