# Technical Memorandum

September 17, 2026

| <b>Project Name</b> | Crescent City Harbor District Marina H Dock Repair Concepts | | |
| <b>Subject</b> | Marina H Dock Repair Concept Summary | | |

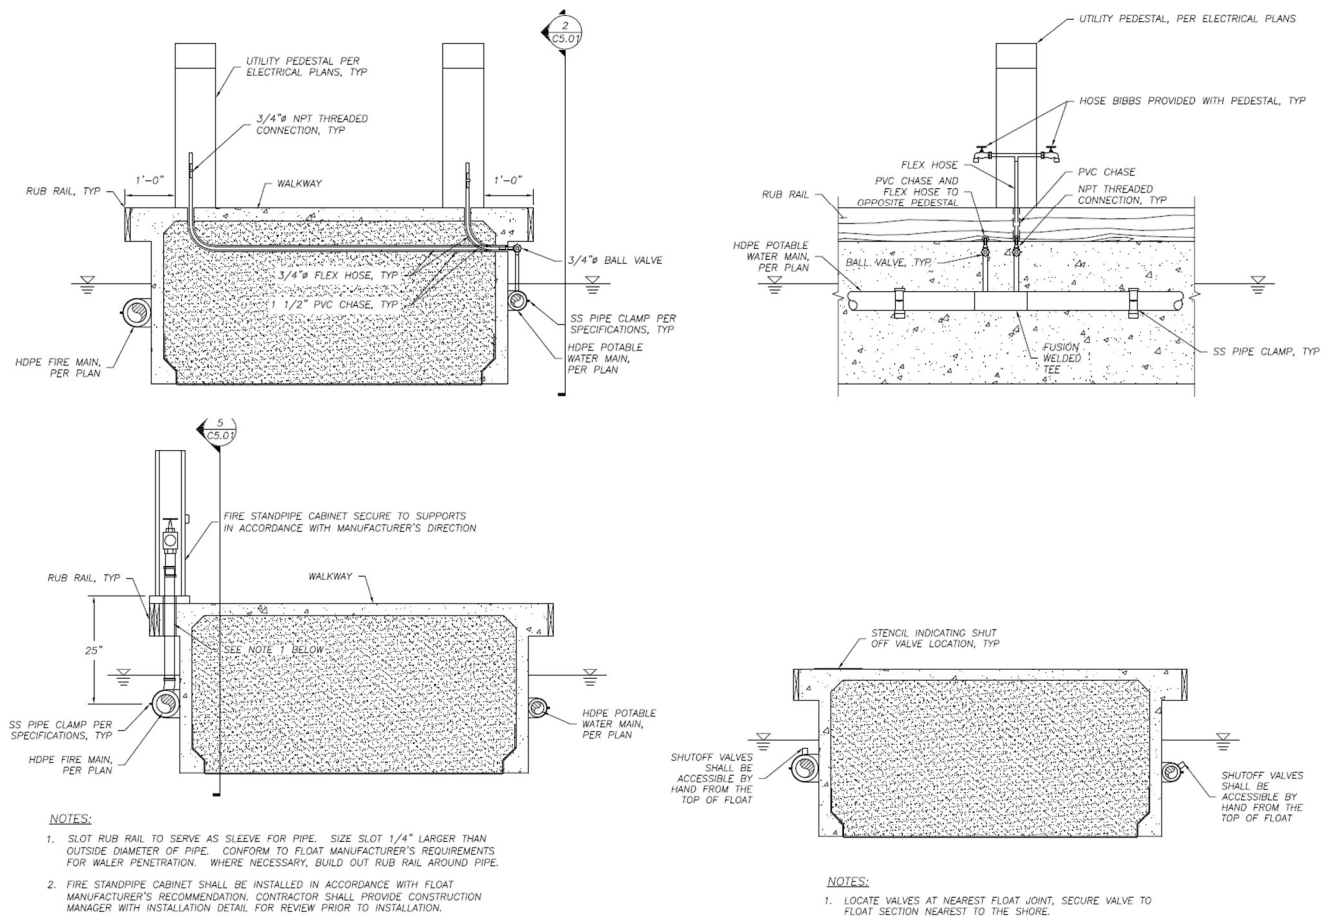
Figure 3: Potable Water and Fire Water HDPE Piping Attached to Side of Docks

- At one location near the east end of H Dock the potable water line is broken between the main line and the hose bibb
- The water line connections (Unistrut anchorage) to the floats are failing or missing in numerous locations.

The M&N report concluded that “The marina water lines should be repaired to restore potable water and fire services. Additionally, the missing, loose and broken pipe hanger attachments and hardware should be replaced and/or reinstalled throughout the marina.”

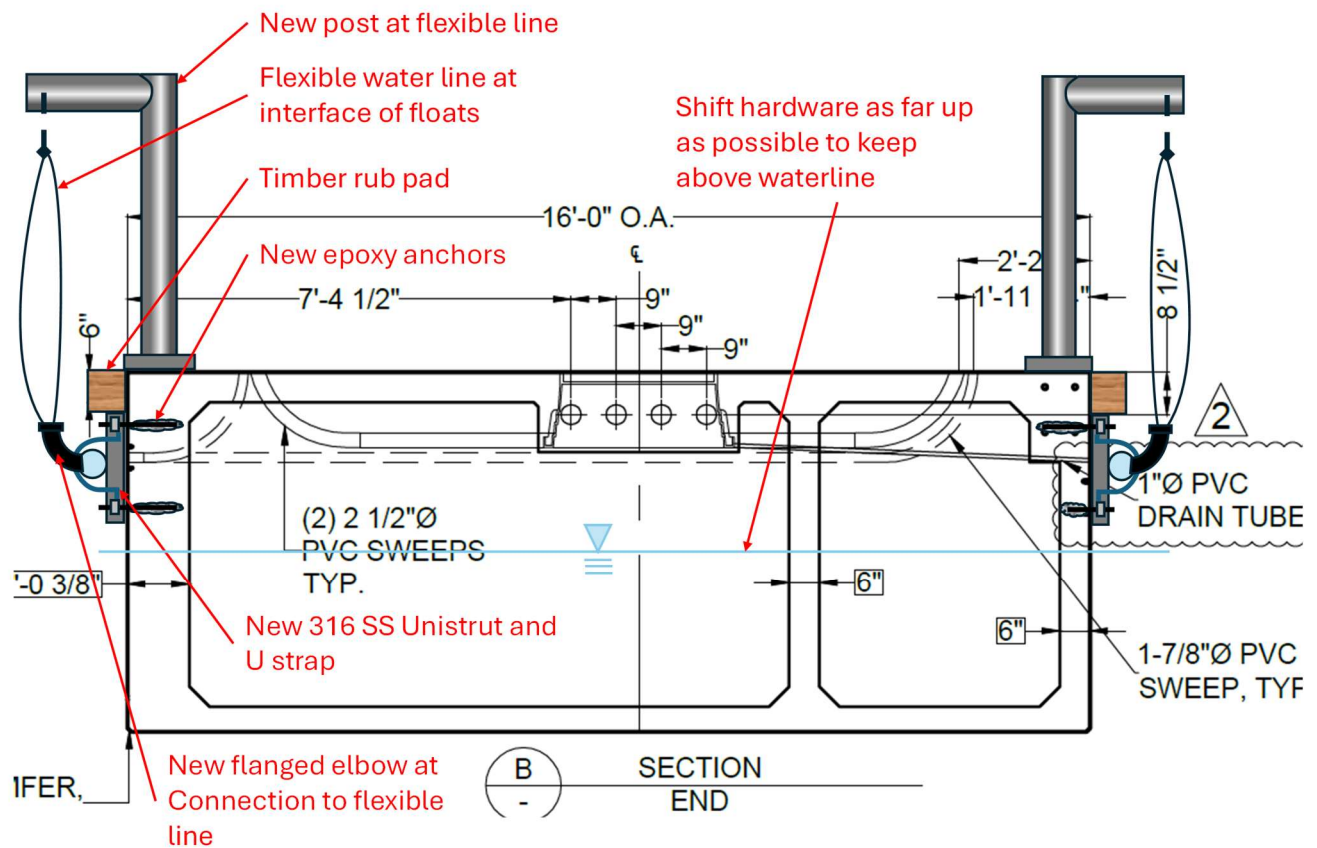
Figure 14: Full System Localized Repair Concept Transverse Section through Float

While the above scheme addresses many of the flexibility issues and maintenance challenges for the existing system, it does not address the ongoing damage experienced using Unistrut. The systematic failure of the brackets does not have a clear root cause and may be due to corrosion, overloading from the HDPE piping due to lack of flexibility, out of spec materials (such as use of 304 stainless versus 316 stainless), or some combination thereof. The localized repair scheme runs the risk of continued challenges following implementation of these repairs, therefore a more resilient repair scheme was also developed.

A longer lead time repair of the full system based on localized relocation and replacement of elements can be performed based on the following, as shown in Figure 14 and Figure 15:

- 5) Spigot valve and pedestal feeder lines will be altered as necessary to accommodate the relocation of the HDPE line. A threaded tee hardware will be installed on the main pipe to accommodate future maintenance of the feeder lines and valves. It may be necessary to add additional elbows to the feeder lines at the face of the concrete float to mitigate interference with the main potable water supply line.
